Report No. WI-2015-08
3 November 2015

The Watershed Institute

2015 Annual Report: Hydrologic Conditions in Baseflow Reaches Pursuant to Conditions 14 and 15, Santa Lucia Preserve, Monterey County, California

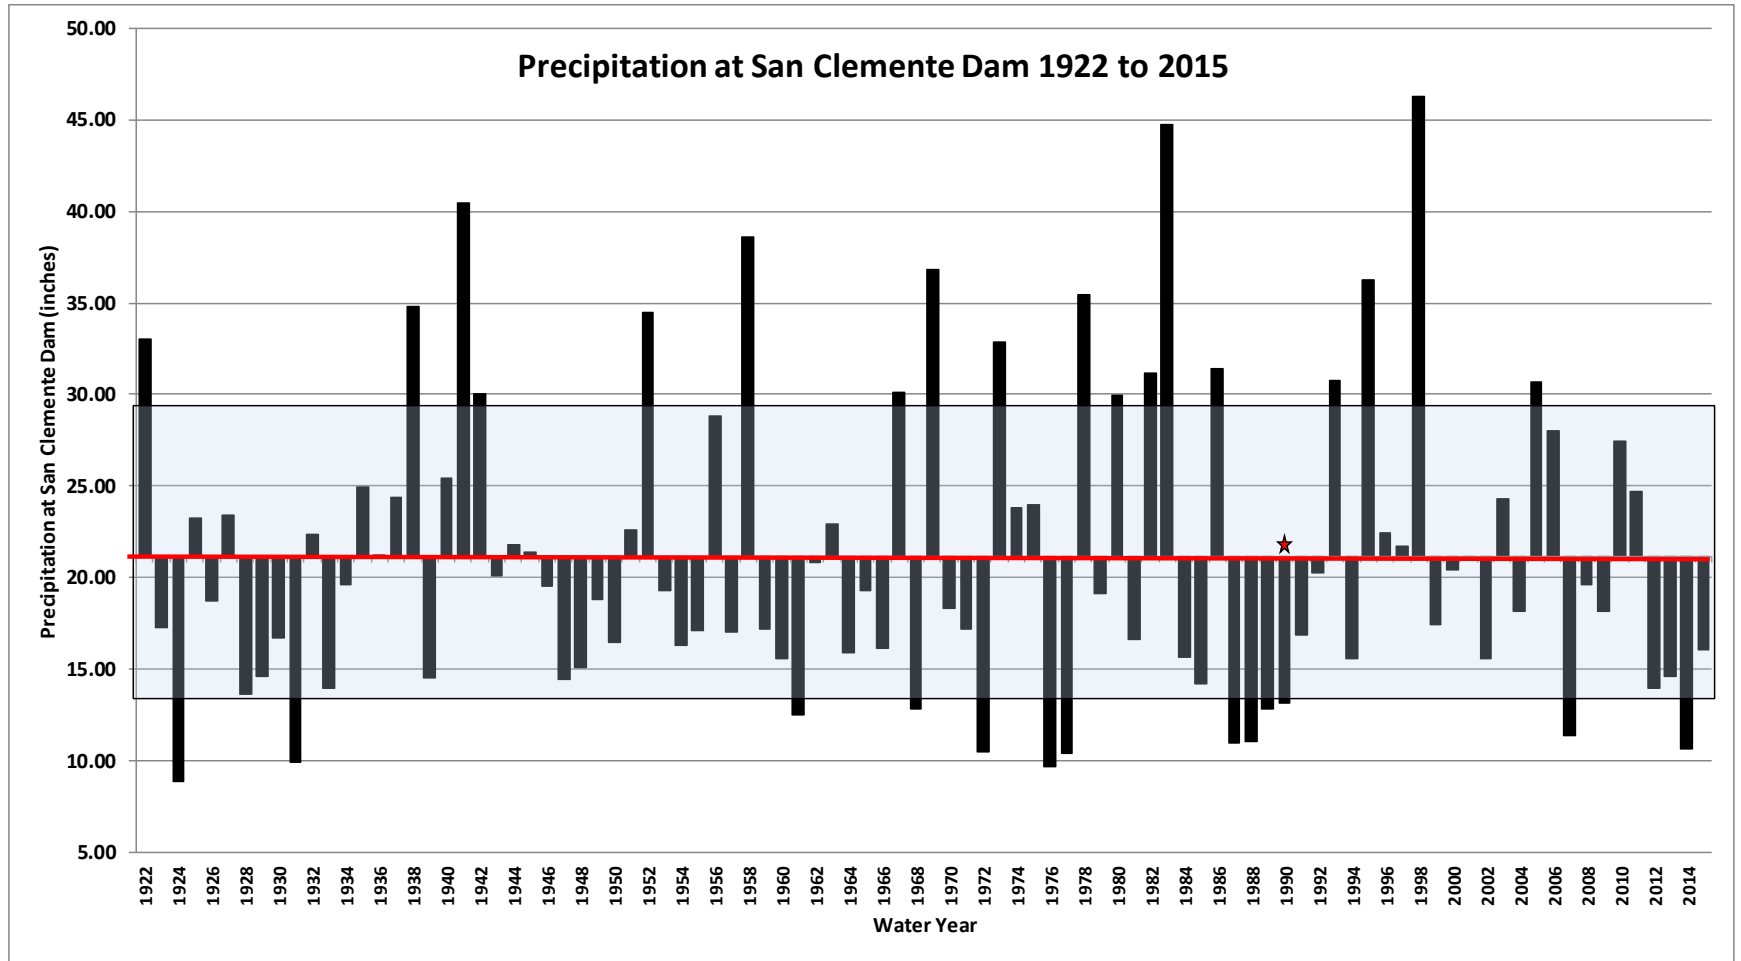
Figure 1. The average annual precipitation at San Clemente Dam for water years 1922-2015 is 21.14 inches (red line). Transparent box uncloses one standard deviation of precipitation above and below the mean. Red star is the 1990 reference year.

The 2015 water year rainfall (16.04 inches) was greater than the 1990 rainfall (13.1 inches) and lower than the average rainfall (21.14 inches). The reference condition in 1990 was the fourth consecutive year with below average rainfall, just as is the case in water year 2015, so we would expect the baseflow in 2015 to be similar to baseflow in 1990. Baseflow expectations were met overall, given that two streams were locally wetter than 1990 and two streams were locally drier than 1990. Given the drought conditions, we cannot determine if the Santa Lucia Preserve Project is the cause of possibly reduced base level flow in San Clemente and Potrero Creeks. Complicating the comparison is that average daily air temperatures in California have been higher than they were in the past, giving rise to higher natural evapotranspiration.

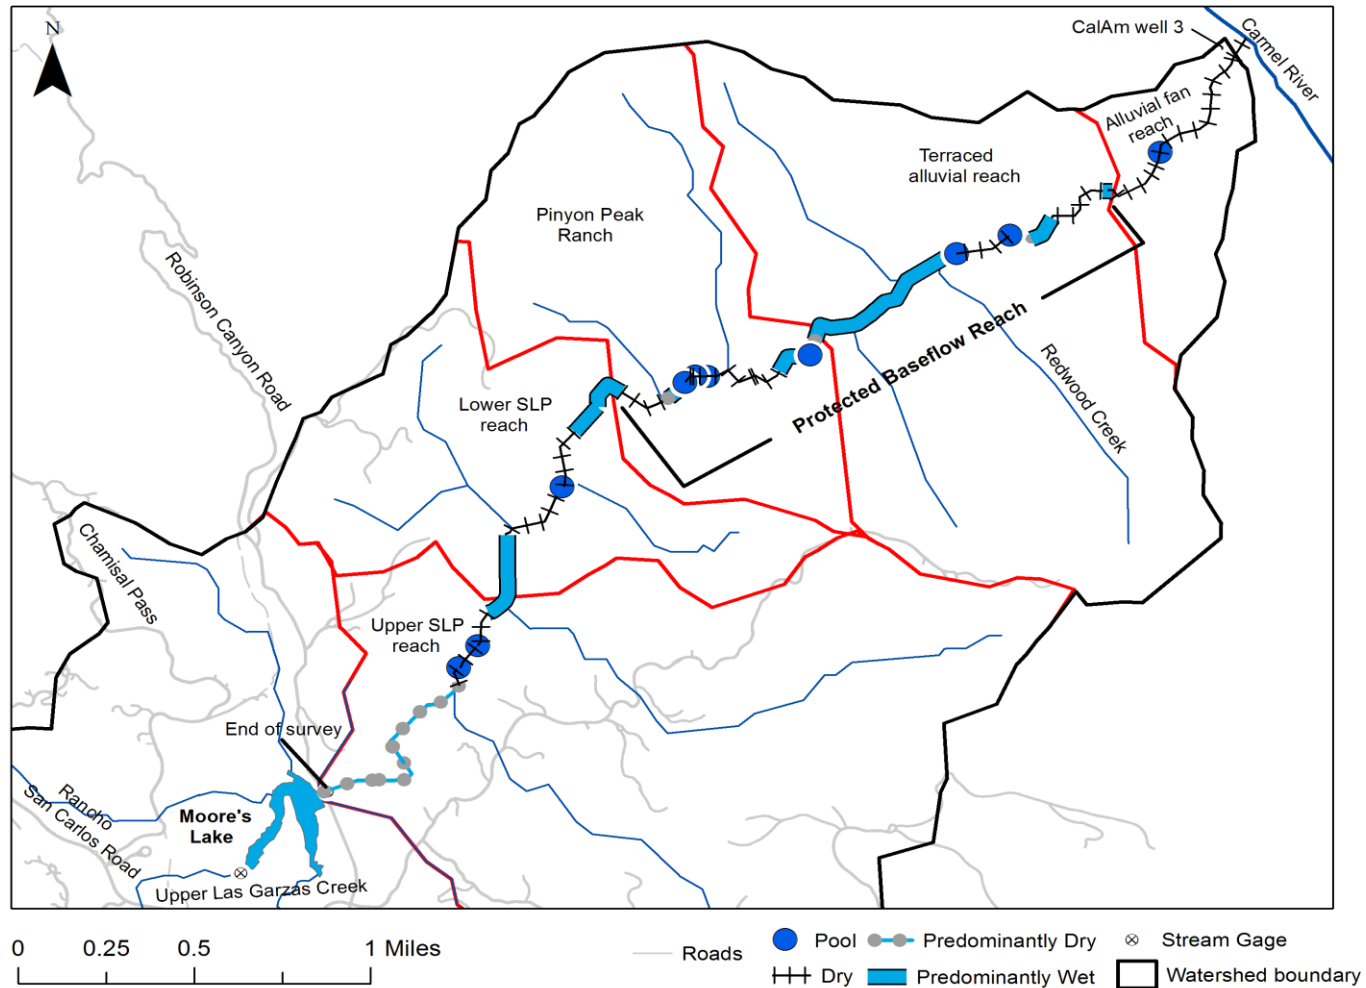
Figure 2. Map of generalized flow conditions for lower Las Garzas Creek on October 9, 2015. In 2015, the Lower SLP reach and the Upper SLP reach had a dry channel with intermittent surface flow at the beginning and end of the two reaches respectively. The Pinyon Peak Reach, the Terraced Alluvial fan reach, and the Alluvial fan reach had a dry channel and brief intermittent surface flow.

A baseflow survey of Lower Las Garzas Creek was conducted on October 9, 2015 (Figure 2). The survey began at the confluence of the Las Garzas Creek and Carmel River and extended upstream to Moore's Lake at Robinson Canyon Road. In October 2015, Garzas had conditions that were slightly wetter conditions as compared to the conditions in October of 1990 (Figure 3). In 2015, the Lower and Upper SLP reaches consisted of a dry or predominately dry channel, with intermittent surface flow and isolated pools in the upstream portion of the Upper SLP reach. The Pinyon Peak Reach had a dry channel and intermittent surface flow with occasional isolated pools. The Terraced Alluvial Reach consisted of a dry channel with intermittent surface flow at the lower end of the reach. The upstream portion of the Alluvial Fan Reach had intermittent surface flow and the downstream portion was dry. This portion of the creek was apparently slightly wetter than 1990, given the intermittent surface flow in the Alluvial Fan Reach where there was none in 1990. The Lower SLP reach was dry in both 1990 and 2015. In 1990, the majority of the "Protected Baseflow Reach" was dry or predominately wet, and, similarly, in 2014 the "Protected Baseflow Reach" was dry with intermittent flow and occasional isolated pools.

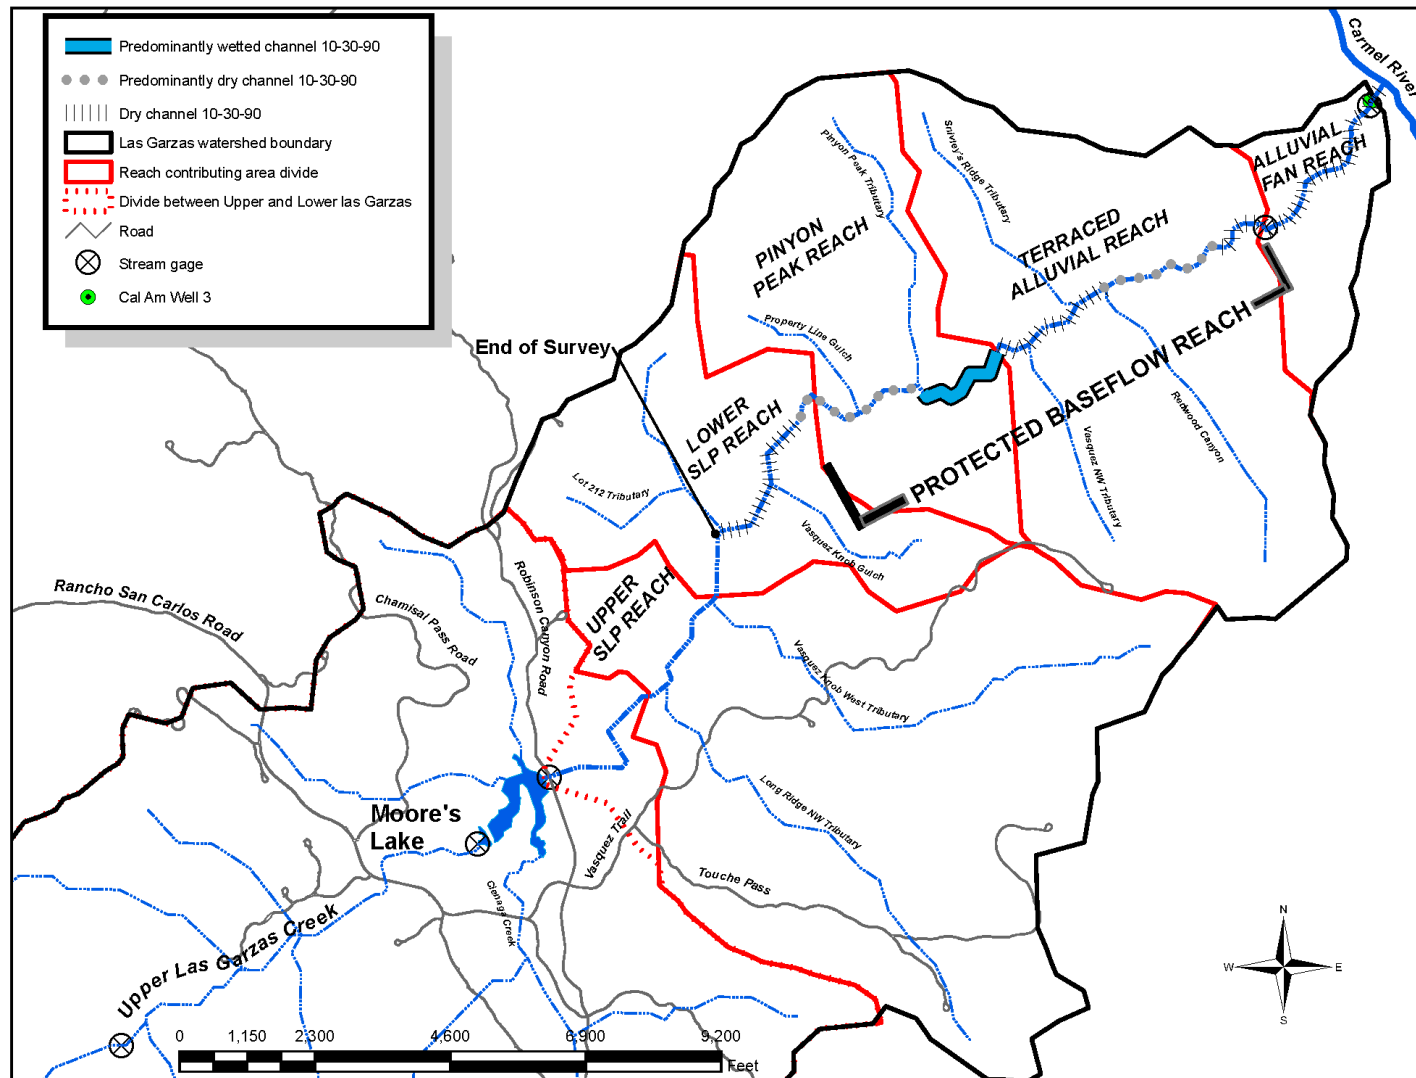
October 30, 1990: Lower Las Garzas Creek Generalized Wetted and Dry Conditions

Figure 3. Generalized flow conditions on Lower Las Garzas Creek on October 30, 1990. In 1990, the upper part of Pinyon Pk. Reach consisted of isolated pools while the lower part of that reach had some continuous flow. Surface flow was not observed in the lower reaches.

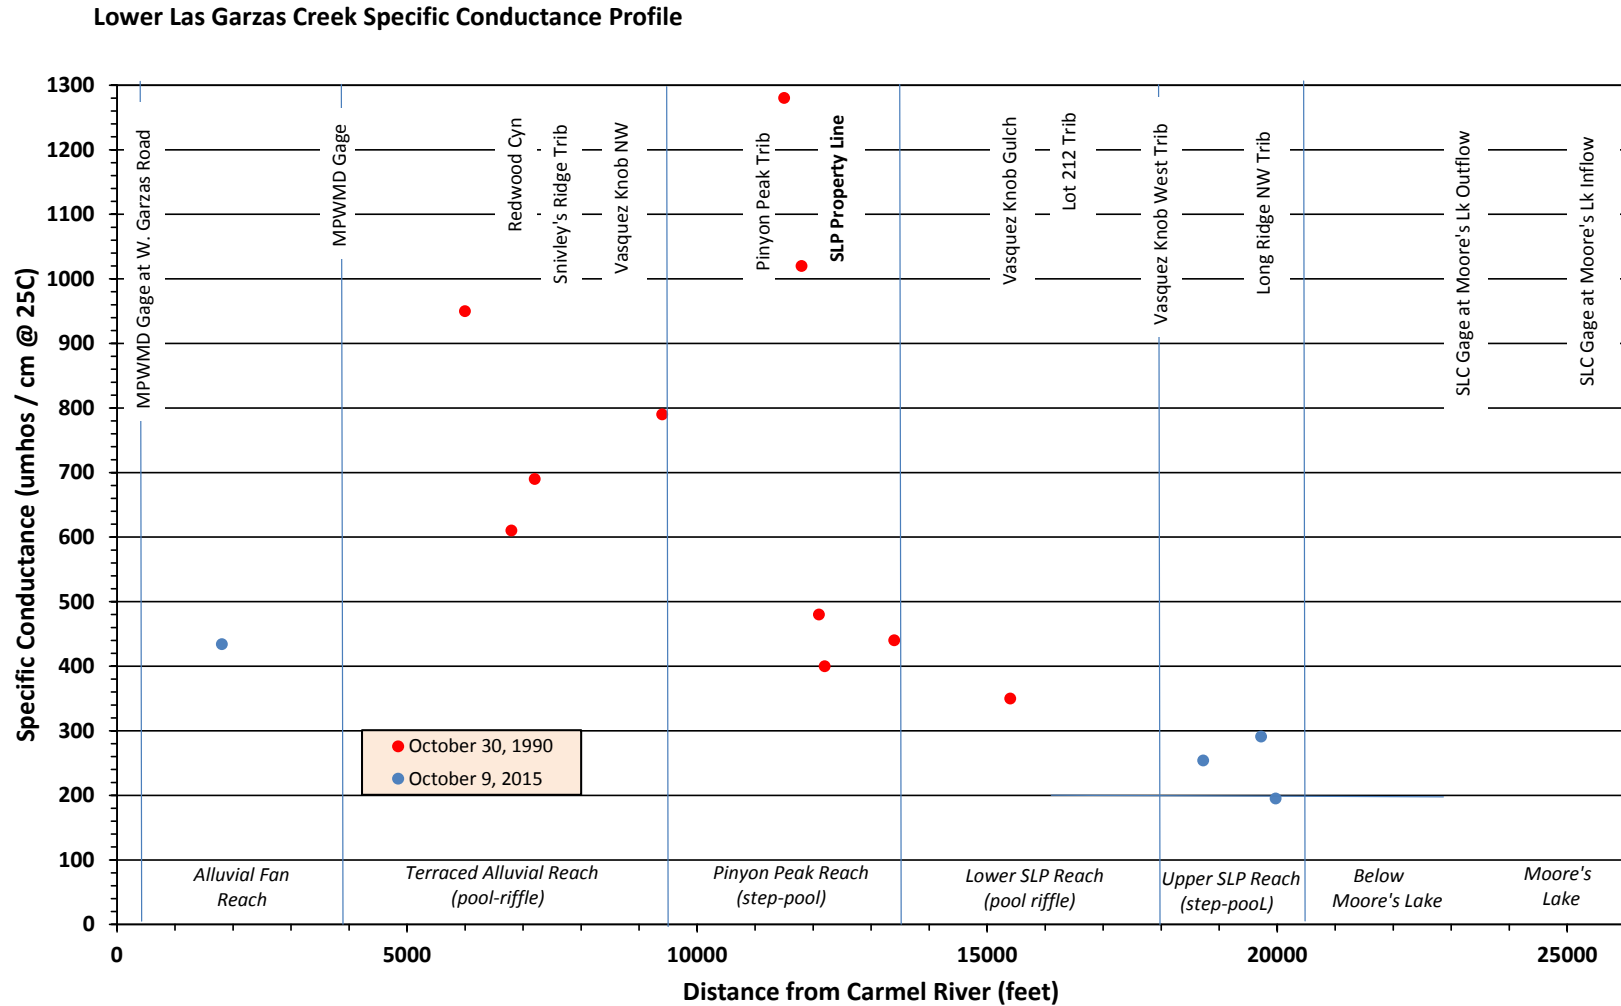
Figure 4. The comparison of Lower Las Garzas Creek specific conductance measurements from October 30, 1990 and October 9, 2015 illustrated the 2015 specific conductivity was lower than 1990 conditions downstream and similar to 1990 conditions upstream. The specific conductivity data for 1990 was extremely variable, so it is very difficult to "characterize" the data for 1990 with a meaningful average.

Specific conductivity was extremely variable in 1990. The specific conductance from 2015 is lower than 1990 but generally follows the same spatial trend (Figure 4).

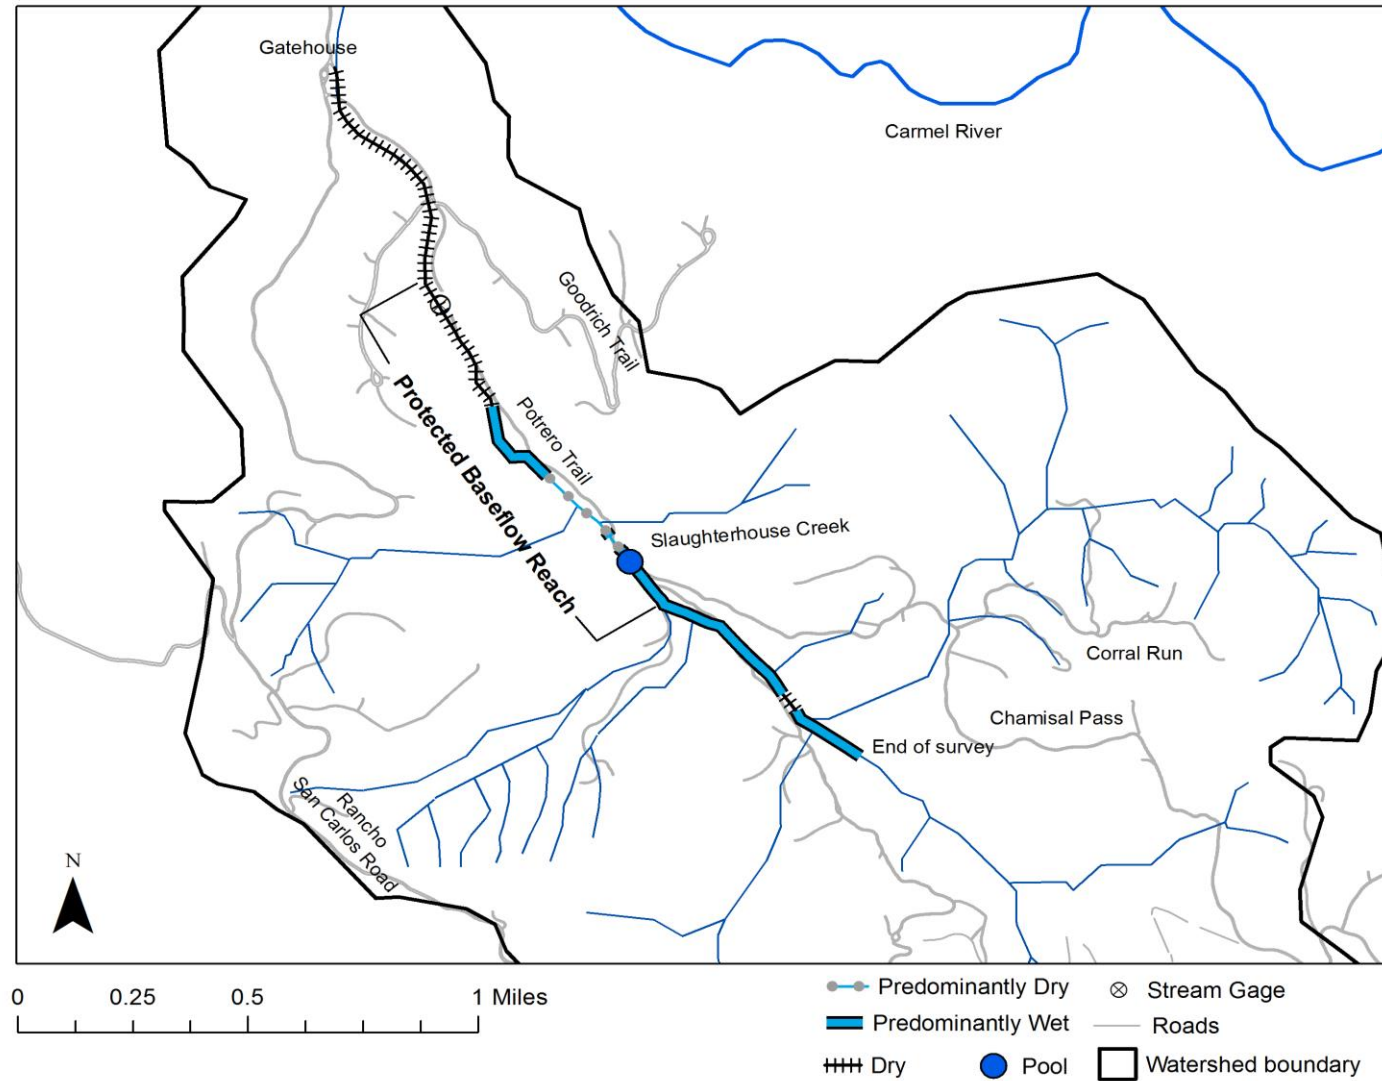
Figure 5. Map of generalized flow conditions on Potrero Creek on August 28, 2015. There was continuous surface flow throughout the mid “Protected Baseflow Reach.” Downstream of the “Protected Baseflow Reach” the channel was dry. The upper reach was mainly dry with intermittent surface flow.

The Potrero Creek baseflow survey was conducted on August 28, 2015. The survey extended from the SLP gatehouse to Potrero Trail Bridge crossing (Figure 5). There was nearly continuous surface flow throughout the mid portion of the "Protected Baseflow Reach" while the lower portion was dry and the upper portion was predominantly dry. Downstream of the "Protected Baseflow Reach" the channel was dry. The upper reach was predominantly dry with intermittent surface flow. Wolshner et al. (2004) describes the "Protected Baseflow Reach" section as surveyed in 1990 as having locally discontinuous flow (Figure 6). In 2015, Potrero Creek was similar to 1990 conditions, but may have had a shorter reach of continuous flow in 2015.

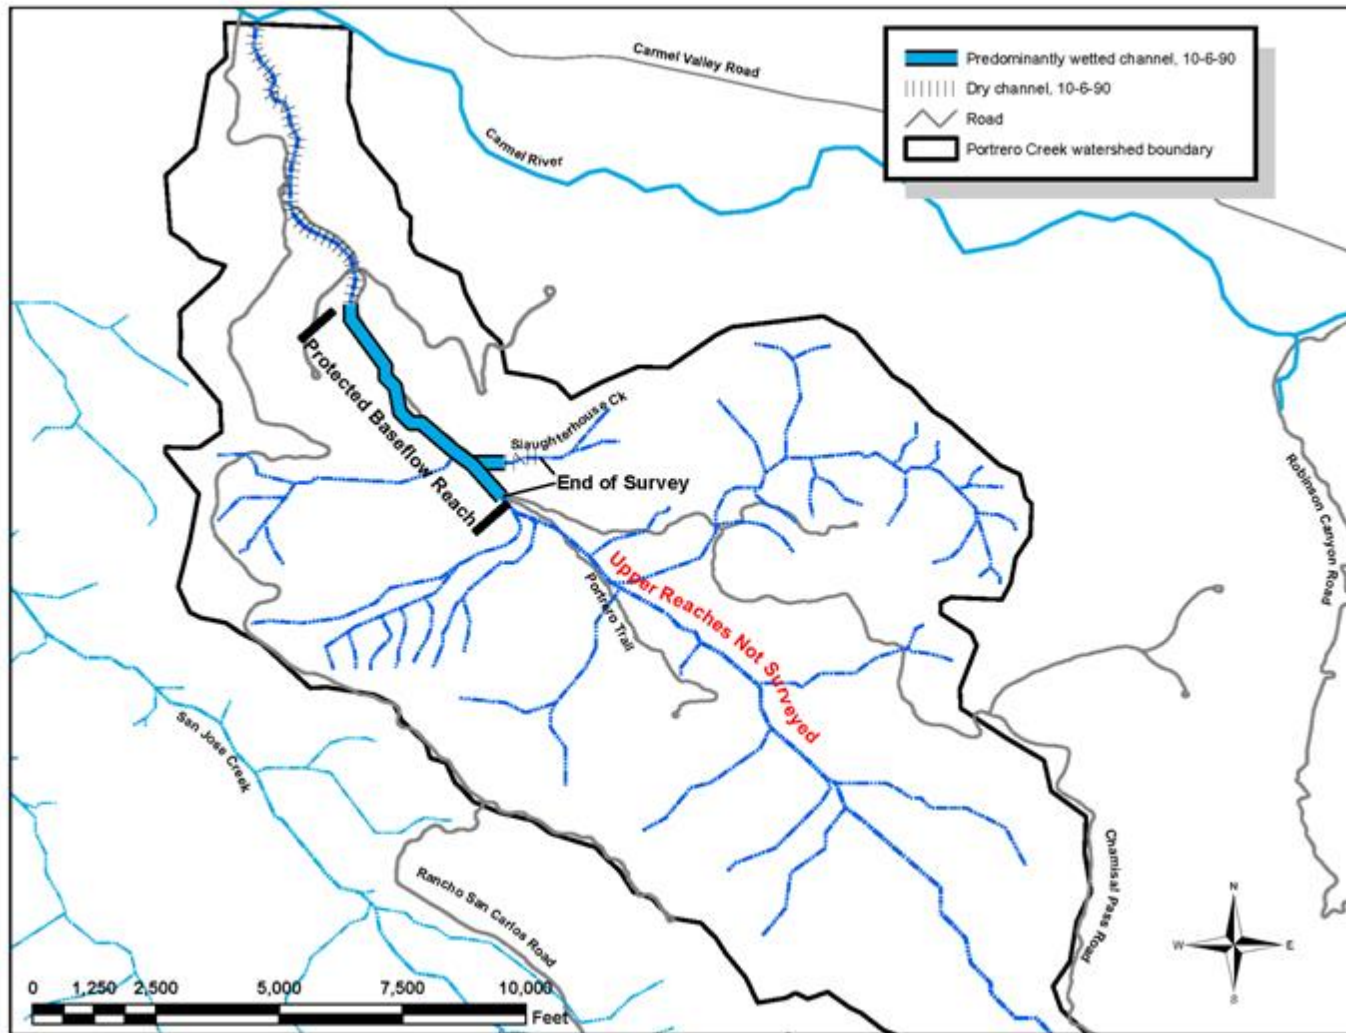
October 06, 1990: Portrero Creek Generalized Wetted and Dry Conditions

Figure 6. Generalized flow conditions on Potrero Creek on October 6, 1990.

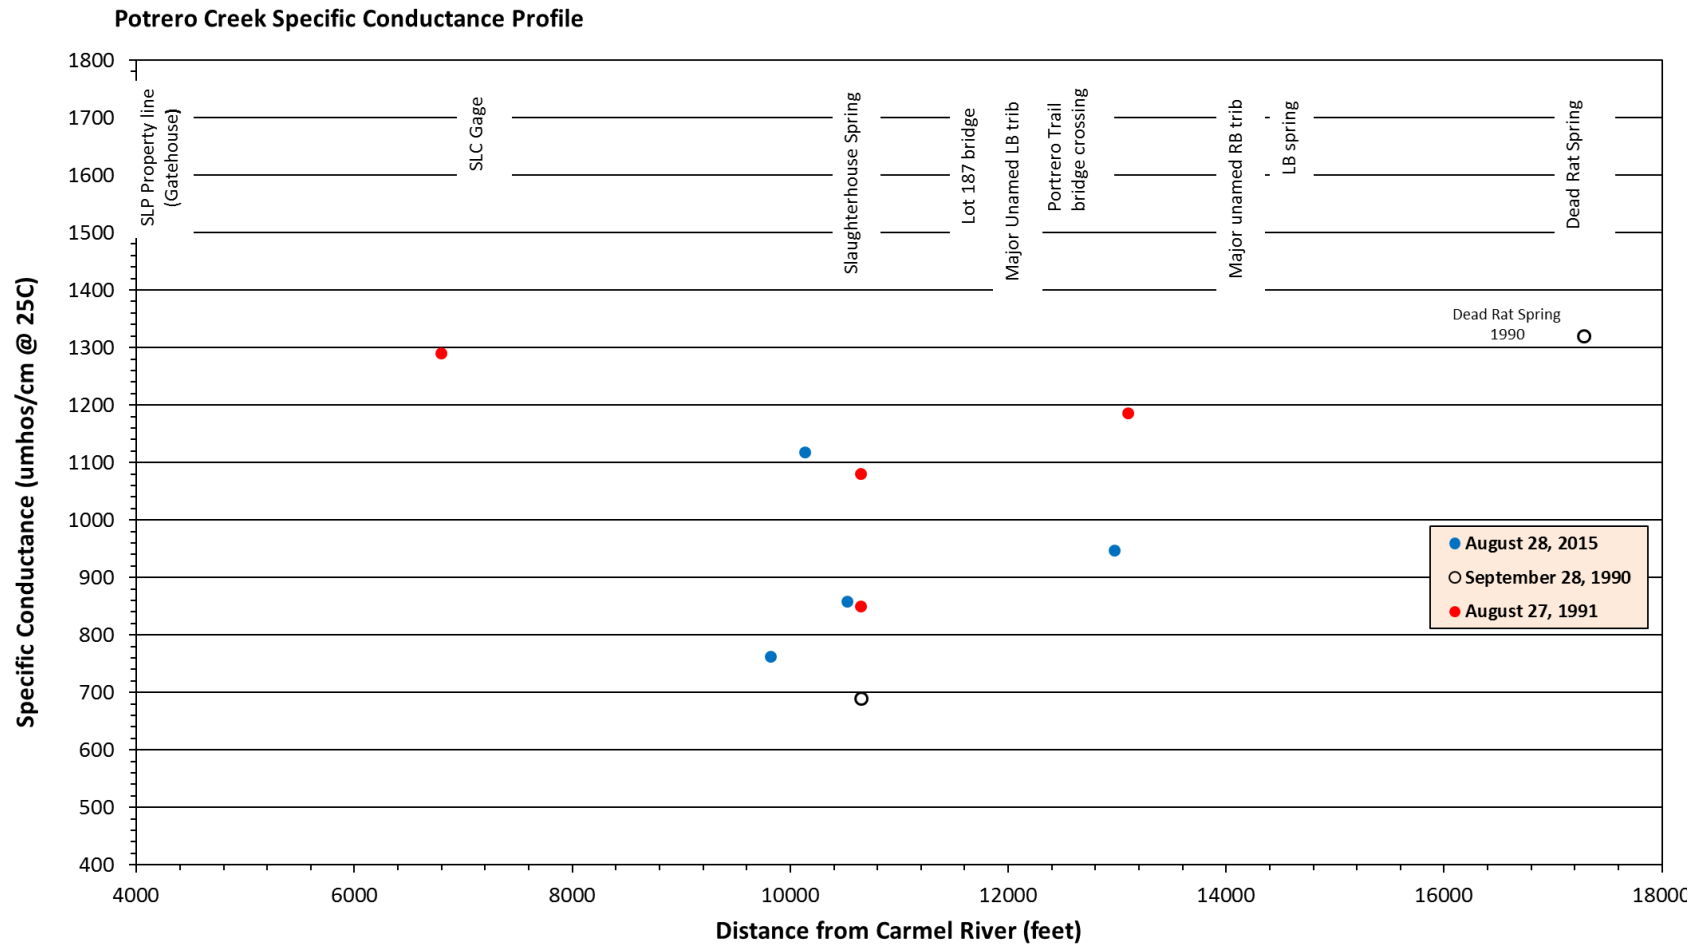
Figure 7. The comparison of Potrero Creek specific conductance measurements from September 1990, August 1991 and August 2015 illustrated the 2015 specific conductivity comparable to 1990 and 1991 conditions.

Two specific conductance measurements were taken during the 1990 survey and four measurements were taken during the 1991 survey. Conditions in 1991 were wetter than 1990, but still well below average. The Potrero Creek specific conductance measurements taken in 2015 were generally equivalent to the 1991 measurements (Figure 7). Historically, Potrero

Creek conductivity measurements have consistently been relatively high compared to other creeks on the Santa Lucia Preserve.

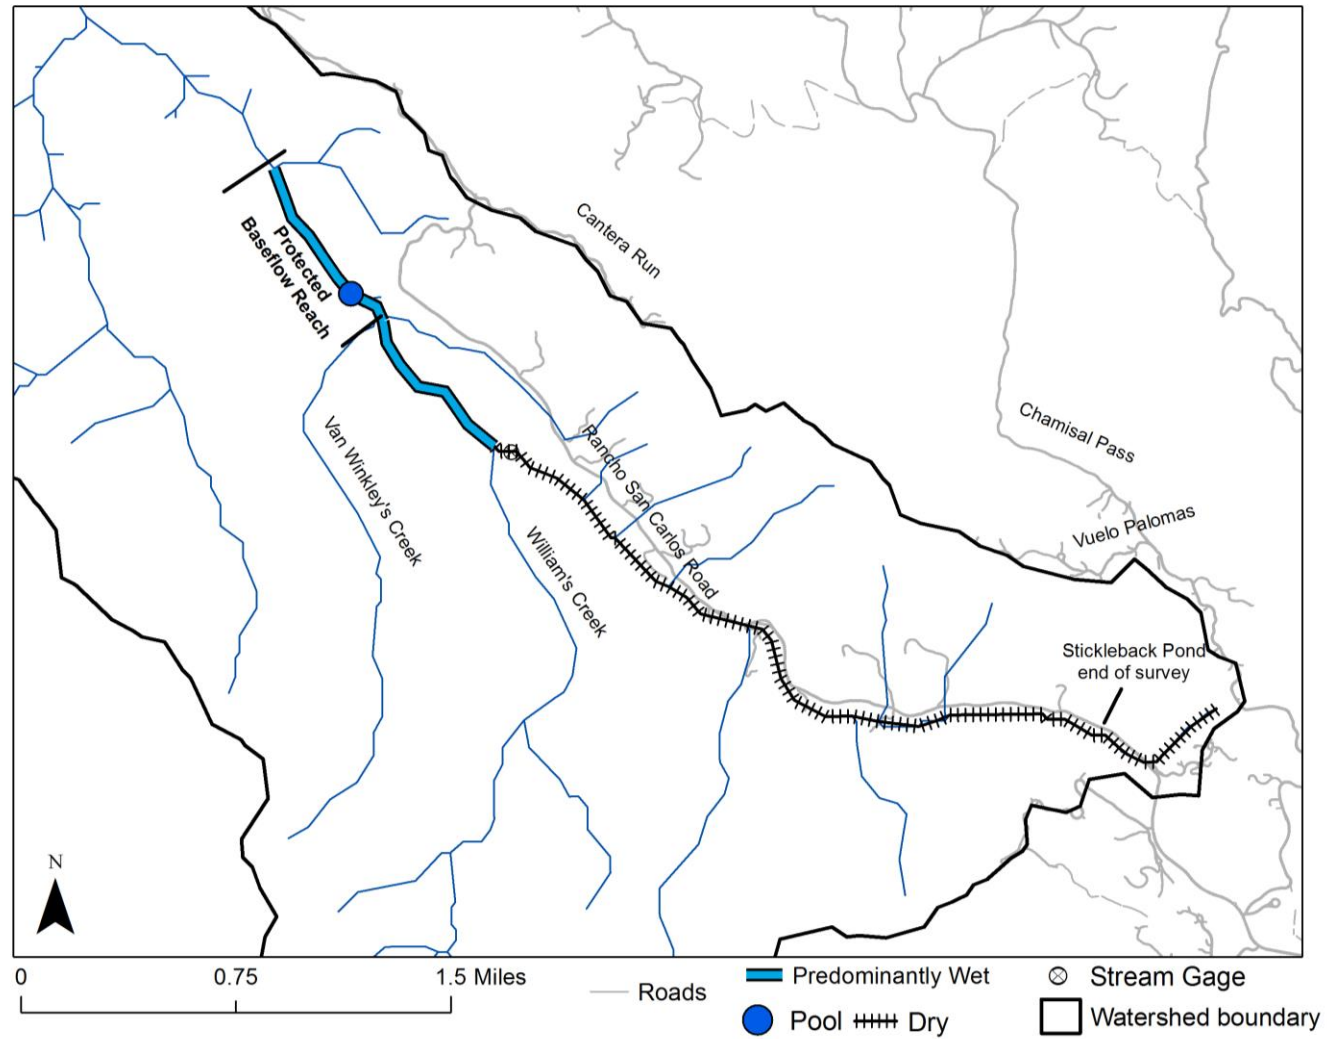
Figure 8. Map of generalized conditions on San Jose Creek on September 11, 2015. There was continuous surface flow in the “Protected Baseflow Reach” and dry conditions for the remainder of the surveyed reach with intermittent surface flow.

The San Jose Creek baseflow survey was conducted on September 11, 2015. The survey began at the SLP property line and extended upstream to Stickleback Pond (Figure 8). There was continuous surface flow in the “Protected Baseflow Reach.” The reach from Van Winkley’s Creek to William’s Canyon, outside of the “Protected Baseflow Reach,” was predominately wet and the rest was dry. The 1990 survey was discontinued above Van Winkley’s Canyon and found predominantly dry conditions for the majority of the survey (Figure 9). In 2015, San Jose Creek was apparently “wetter” than 1990 conditions.

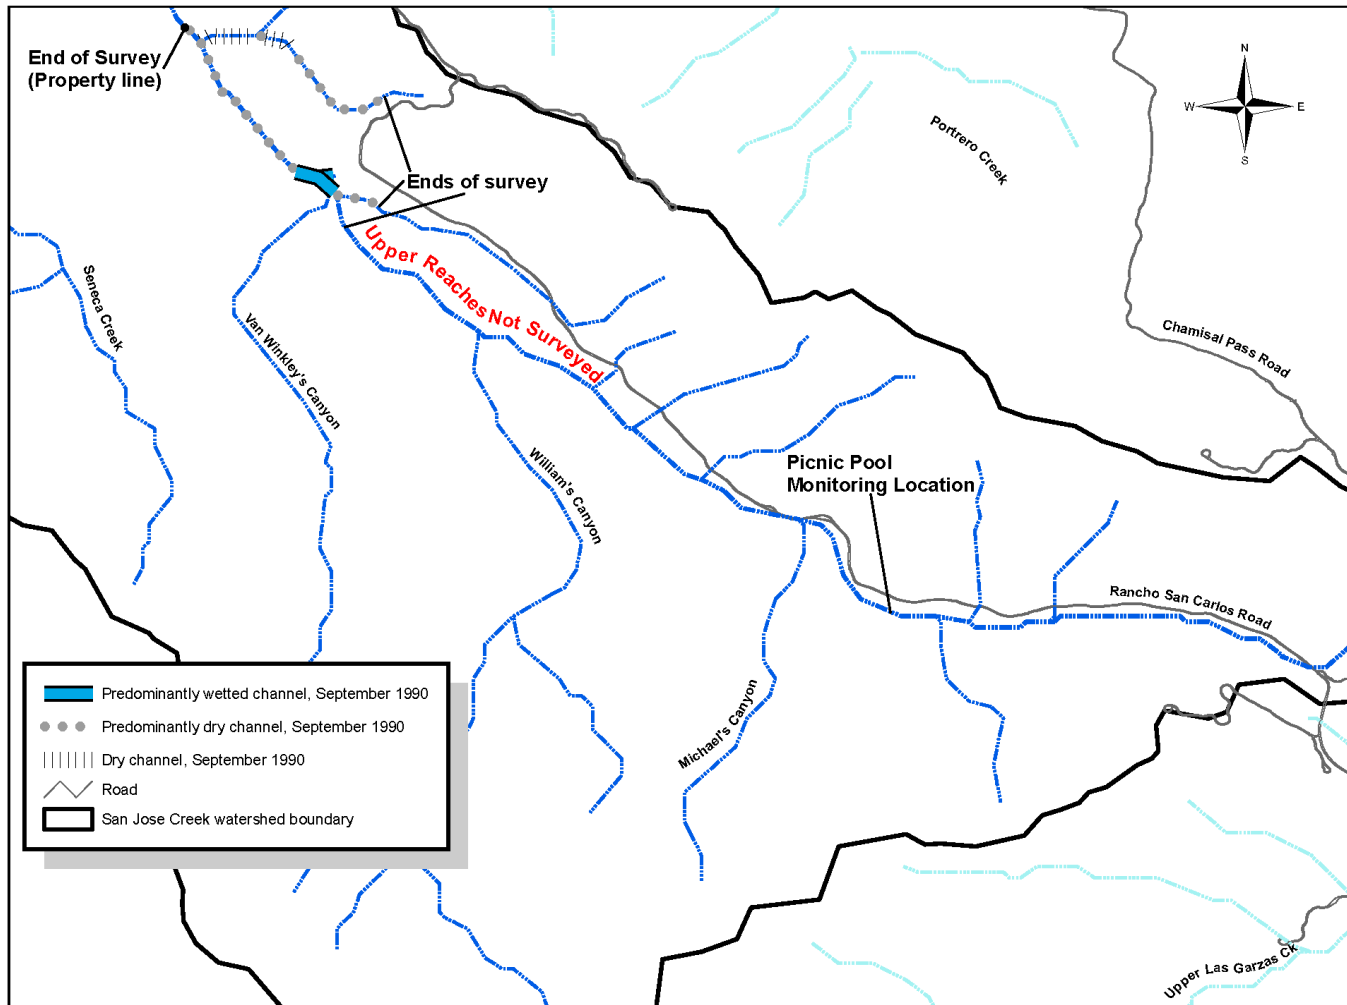
September 1990: San Jose Creek Generalized Wetted and Dry Conditions

Figure 9. Generalized flow conditions on San Jose Creek in September 1990.

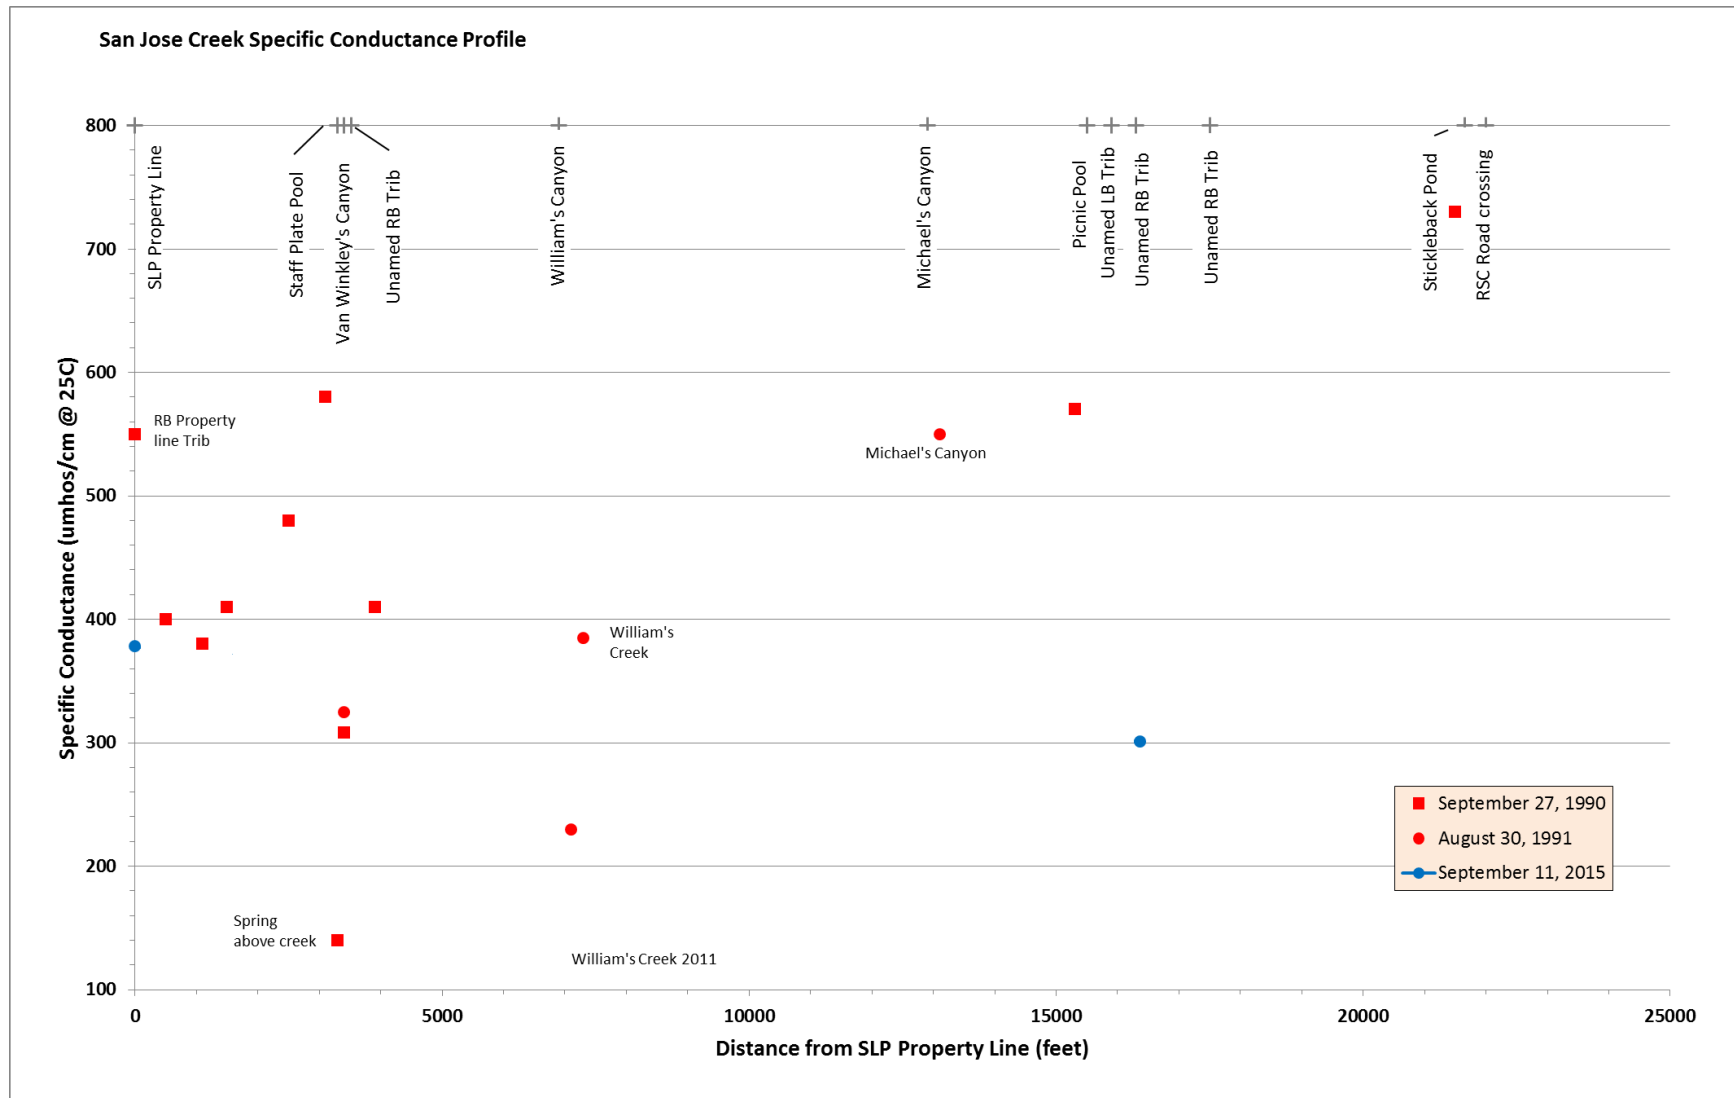
Figure 10. The comparison of San Jose Creek specific conductance measurements from September 1990, August 1991 and September 2015 illustrated the 2015 specific conductivity was generally equivalent or lower than 1990 and 1991 conditions.

Specific conductance measurements from San Jose Creek were generally equivalent or lower in 2015 than measurements from 1990 (Figure 10). On the San Jose Creek, the trend for specific conductivities is from lower values to higher values with distance upstream.

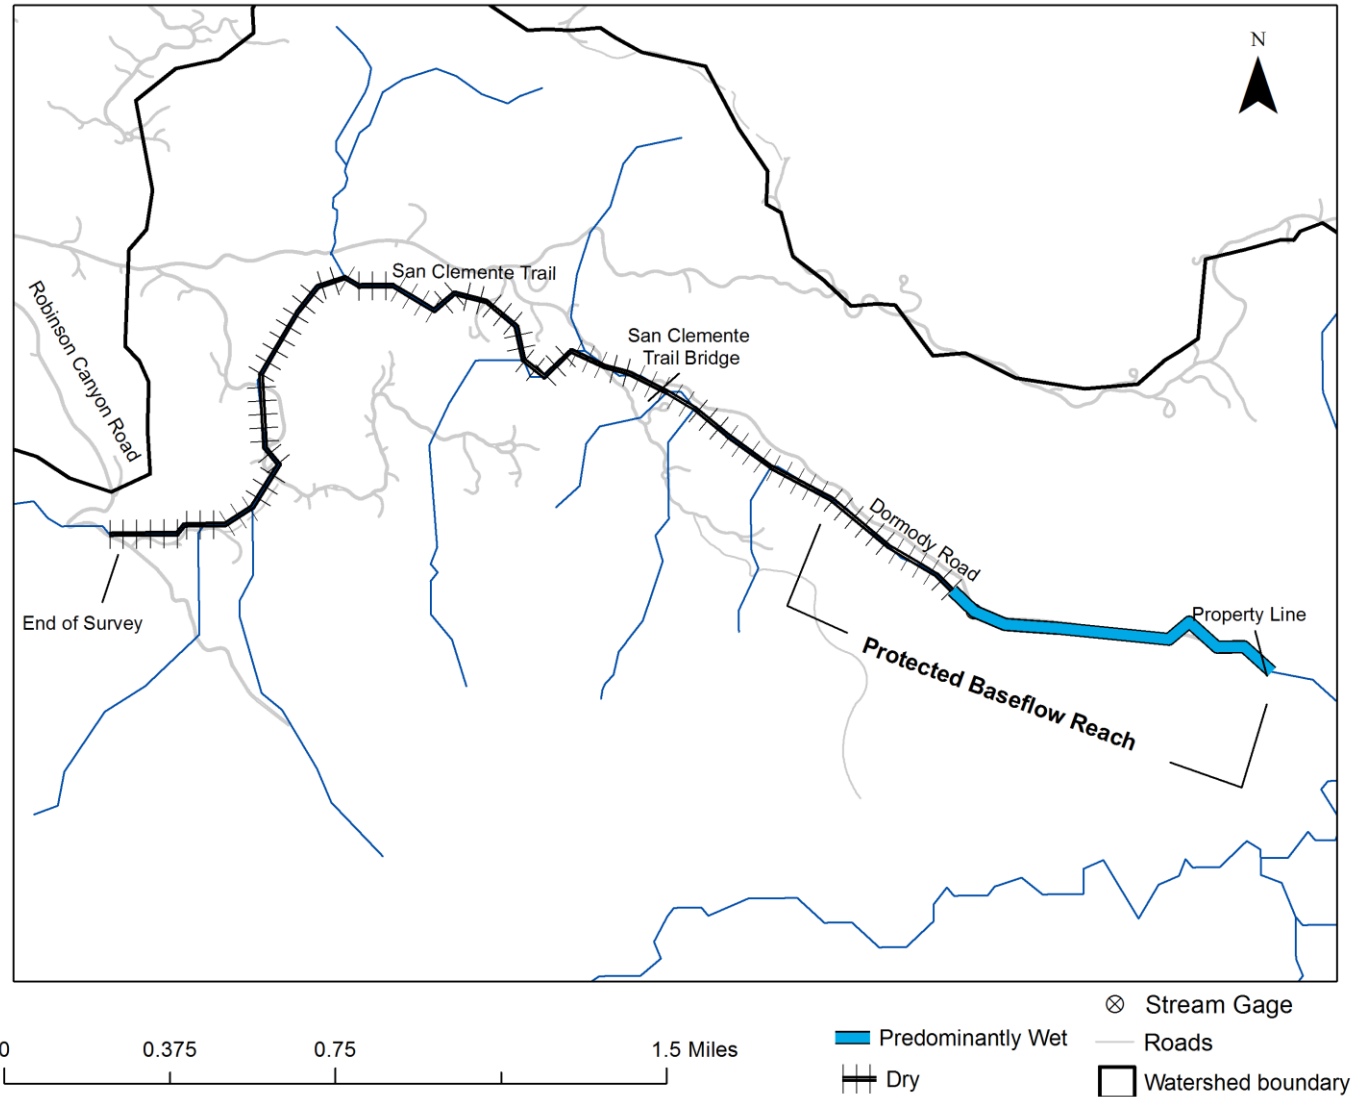
Figure 11. Map of generalized flow conditions on San Clemente Creek on September 20, 2015. There was continuous surface flow in the lower half of the “Protected Baseflow Reach,” while the upstream reach was dry.

The baseflow survey for San Clemente Creek was conducted on September 20, 2015 (Figure 11). The survey began at the SLP property line (Dormody Road) and continued upstream to Robinson Canyon Road. There was continuous surface flow in the lower half of the “Protected Baseflow Reach,” while the upstream reach was dry. During the 1990 survey, San Clemente Creek was surveyed from the San Clemente Trail Bridge to Robinson Canyon Road (Figure 12). No 1990 reference data for the conditions through the “Protected Baseflow Reach” exist. Only one short section was described as predominantly wetted, while the remainder of the creek was described as predominantly dry. More of the creek bed was assessed as predominantly wetted in the 1990 survey than in the 2015 survey.

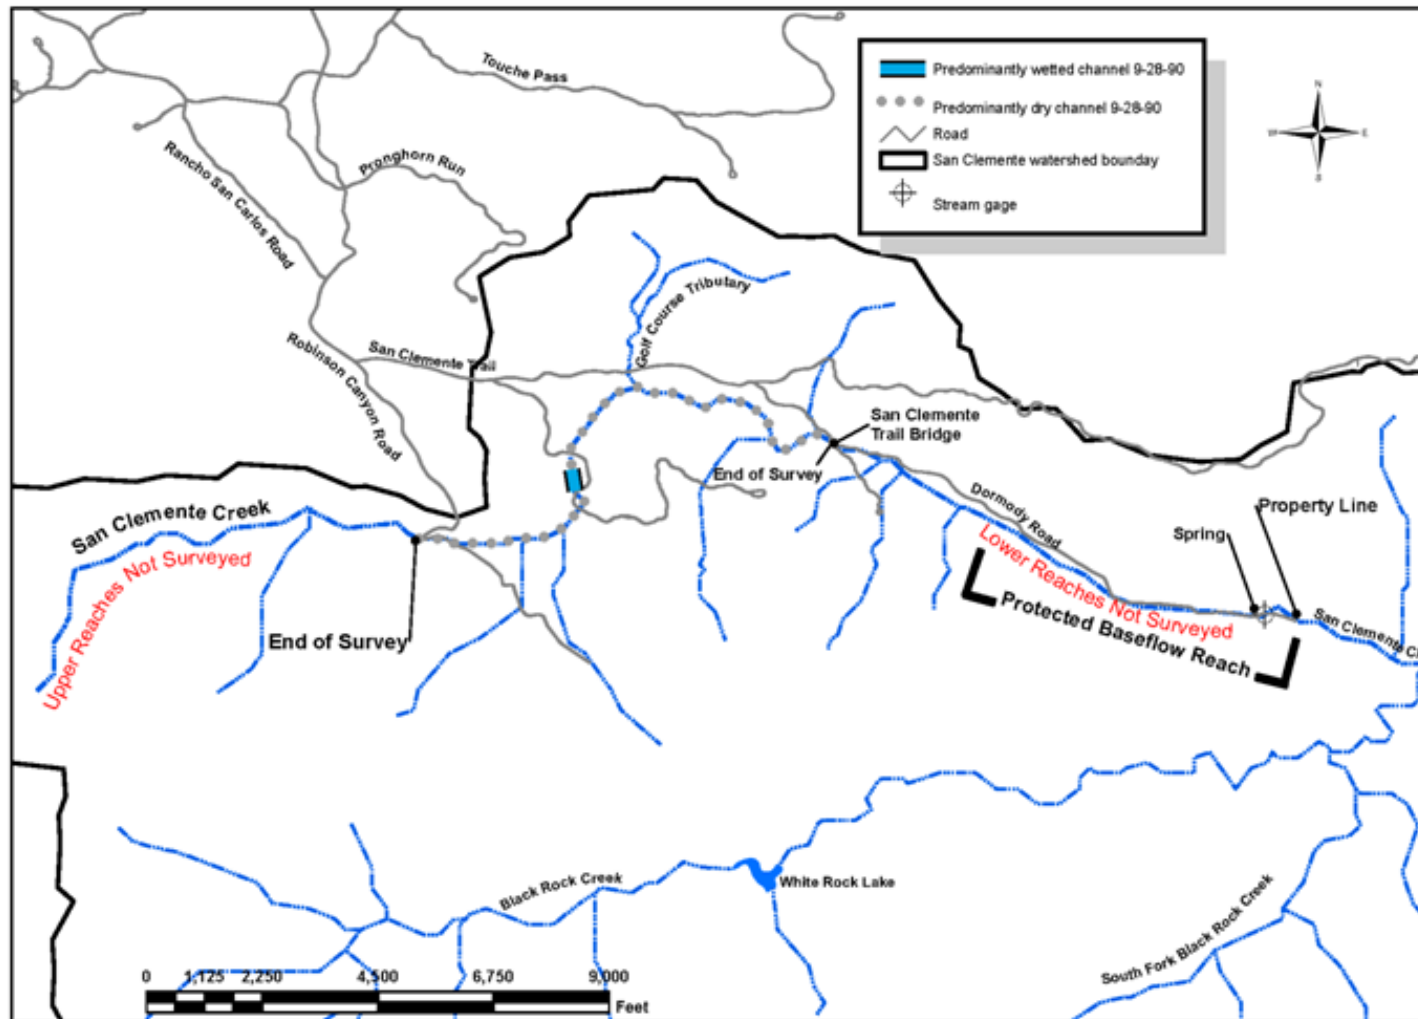
September 28, 1990: San Clemente Creek Generalized Wetted and Dry Conditions

Figure 12. Generalized flow conditions on San Clemente Creek on September 28, 1990.

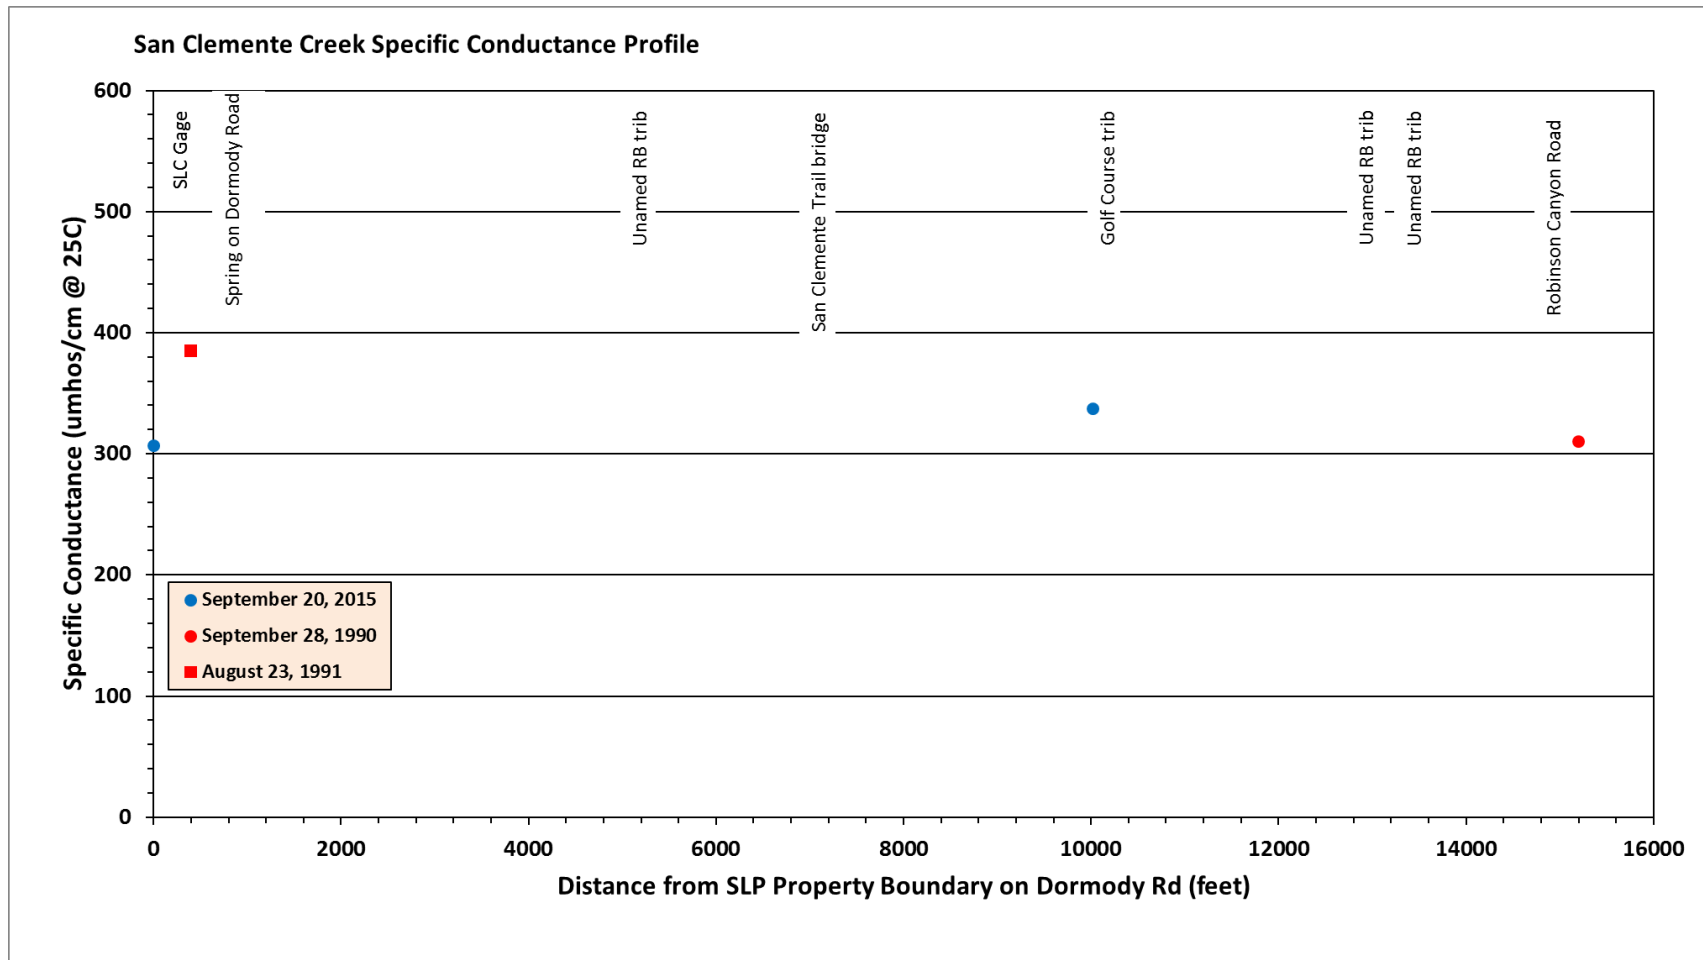
Figure 13. The comparison of San Clemente Creek specific conductance measurements from September 1990, August 1991 and September 2015 illustrated the 201 specific conductivity was slightly lower than 1990 and 1991 conditions at the lower end of the reach and higher at the upper end of the reach.

One specific conductance measurements was taken during both the 1990 and 1991 surveys. Specific conductance data from 2015 fall between the 1990 and 1991 surveys (Figure 13). Compared with the sparse reference data that exists for 1990 conditions and the continuous surface flow in the “Protected Baseflow Reach,” San Clemente Creek specific conductance is equivalent to 1990 conditions.
